**DEPARTMENT OF TRANSPORTATION**

Contract #: 04-0120F4Cty: SF/ALA Rte: 80 PM: 13.2/13.9File #: 1.28**WELDING INSPECTION REPORT****Resident Engineer:** Casey, William**Address:** 333 Burma Road**City:** Oakland, CA 94607**Report No:** WIR-027208**Date Inspected:** 16-Feb-2012**Project Name:** SAS Superstructure**OSM Arrival Time:** 700**Prime Contractor:** American Bridge/Fluor Enterprises, a JV**OSM Departure Time:** 1730**Contractor:** American Bridge/Fluor Enterprises, a JV**Location:** Jobsite**CWI Name:** As noted below**CWI Present:** Yes No**Inspected CWI report:** Yes No N/A**Rod Oven in Use:** Yes No N/A**Electrode to specification:** Yes No N/A**Weld Procedures Followed:** Yes No N/A**Qualified Welders:** Yes No N/A**Verified Joint Fit-up:** Yes No N/A**Approved Drawings:** Yes No N/A**Approved WPS:** Yes No N/A**Delayed / Cancelled:** Yes No N/A**Bridge No:** 34-0006**Component:** SAS OBG**Summary of Items Observed:**

**13E PP118.2 E5 Vent Hole (Exterior)**

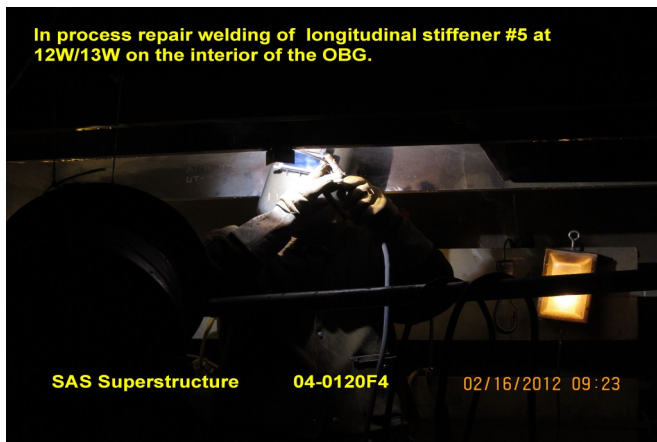
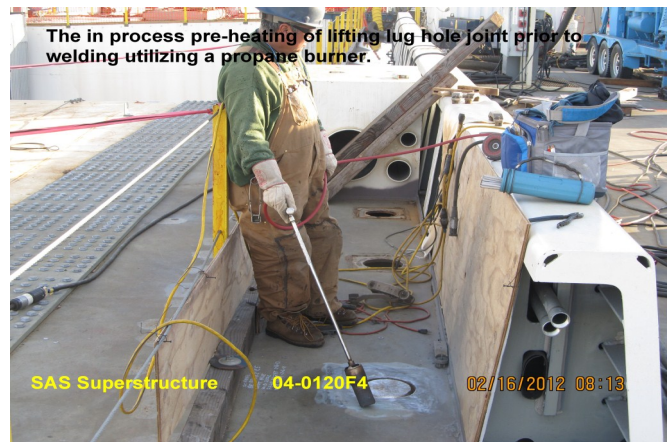
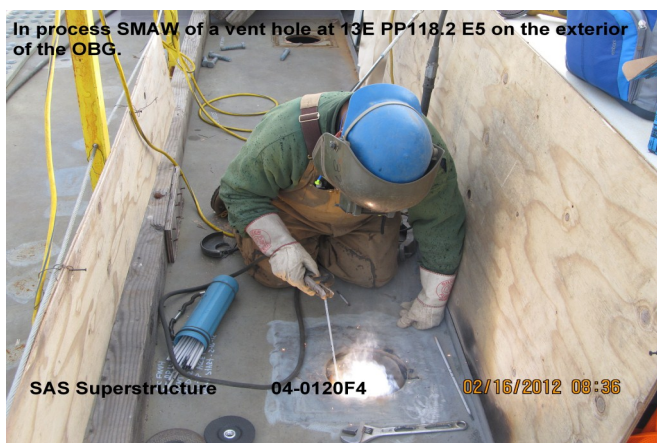
This QA Inspector observed QC Inspector Fred Von Hoff utilize a Bridge Cam Gage to measure the fit-up of the 20 mm plate in the B-U4a joint on vent hole 13E PP118.2 E5. This QA Inspector verified the fit-up as acceptable and employed a 66°C Tempilstik to ensure the minimum pre-heat temperature had been achieved. This QA Inspector randomly observed ABF welder Salvador Sandoval (welder ID 2202) performing the Shielded Metal Arc Welding (SMAW) process in the (1G) flat position and observed the QC Inspector verify the welding parameters were in accordance with ABF-WPS-D1.5-1050A-CU. This QA Inspector made subsequent observations throughout the shift to monitor quality and noted that the work is in progress and appeared to be in general compliance with the contract specifications.

This QA Inspector randomly observed ABF Quality Control Inspector Mr. Harry Scharein performing Ultrasonic Testing (UT) inspection on "A" deck lifting lug holes #1-4 at 13E PP118.5 E4 on the exterior of the OBG. This QA Inspector observed that Mr. Scharein detected a rejectable ultrasonic indication on LLH #3 at y+0mm; 2mm's in length and 18mm's deep with an indication reading of +10db's. The deck at this location is

This QA Inspector randomly observed QC Inspector Sal Merino perform fit-up operations on lifting lug hole #4 at 13W PP119.5 W3. The QC Inspector utilized a Bridge Cam Gauge to measure the planar offset to be within + or - 1 mm from "A" deck and this QA Inspector verified the fit-up as acceptable and employed a 66°C Tempilstik to ensure the minimum pre-heat temperature had been achieved. This QA Inspector randomly observed ABF welder Mike Jimenez (welder ID 4671) performing the SMAW process in the (1G) flat position and observed the QC Inspector verify the welding parameters were in accordance with ABF-WPS-D15-1050A-CU. This QA Inspector made subsequent observations throughout the shift to monitor quality and noted that the work was completed on this date and appeared to be in general compliance with the approved WPS and the contract specifications.

This QA Inspector randomly observed ABF Rory Hogan perform SMAW utilizing E9018-MR electrodes in the 3G vertical position during repair welding operations on LS #5 in the interior of the OBG. This QA Inspector noted that Mr. Hogan employed a propane burner to pre-heat the joint to 200° F prior to welding. QC Inspector Sal Merino was observed measuring the parameters and monitoring the welding to ensure conformance with ABF-WPS-D1.5 1012-3 Repair. This QA Inspector noted that the work was in progress and the parameters and the workmanship appeared to be in general conformance with the contract documents.

This QA Inspector randomly observed ABF welders Rick Clayborn perform back-gouge operations on face "B" of lifting lug holes #3 and 4 on the interior of the OBG. This QA Inspector observed QC Inspector Sal Merino perform MT testing to ensure the soundness of the metal. It was noted that Mr. Merino found no rejectable indications. This QA Inspector randomly observed the welder perform SMAW in the (4G) overhead position with the QC Inspector monitoring the welding to insure the parameters were in accordance with ABF-WPS-D15-1110A-Revision 1. This Q Inspector made subsequent observations throughout the shift to monitor quality and noted that the work was completed on this date and appeared to be in general accordance with the contract documents.

This QA Inspector randomly observed ABF welding operator James Zhen (ID 6001) performing the Flux Core Arc Welding with gas (FCAW-G) process utilizing a “Bug-O” motorized rail system with a magnetic base attached in the (4G) overhead position on the underside of deck plate “A4”, at 13E/14E of the OBG. This QA Inspector observed QC Inspector Fred Von Hoff monitoring the welding to ensure the welding parameters were in compliance pertaining to ABF-WPS-D15-3110-4. The parameters were recorded as (A=250/V=23.8/TS=190/HI=1.87). This QA inspector made subsequent observations throughout the shift to monitor quality and noted that the work was completed on this date and appeared to be in general conformance to the contract requirements.
